SURFACE MINING INSPECTION REPORT

I. Mining Operation Name WHALE ROCK QUARRY	CA Mine ID #
------------------------------------------------------	--------------

MAININI PIT at
Whale Rock

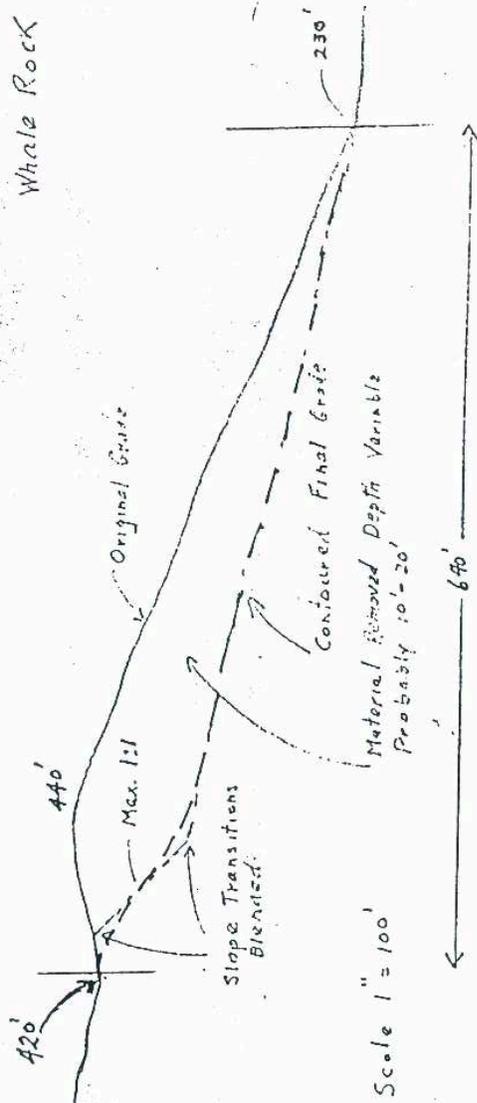
After Excavation Topsoil Replaced
Natural Revegetation assisted by Seeding
Adapted Species:

Reclamation Treatment - Unconsolidated Material - Dry
