KEITH V. CROWE, PE, PLS
CONSULTING ENGINEER

Evaluation and Recommendations
of the
Public Access Road to
Kiler Ridge Olive Farm

Prepared at the request of
Kiler Ridge Olive Farm

3/10/2015

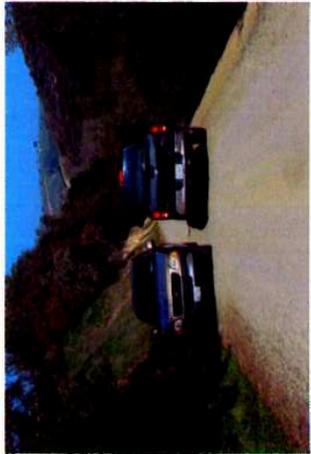
Figure 1 Narrowest section

To determine if the road is wide enough to allow safe two-way traffic two full-sized pickup trucks were used to gage the width of the road. Figures 1, 2 and 3 show the two trucks side-by-side at the narrowest portion of the road. Photographs of the trucks at a typical (19') wide section are shown in figures 4,5 and 6.

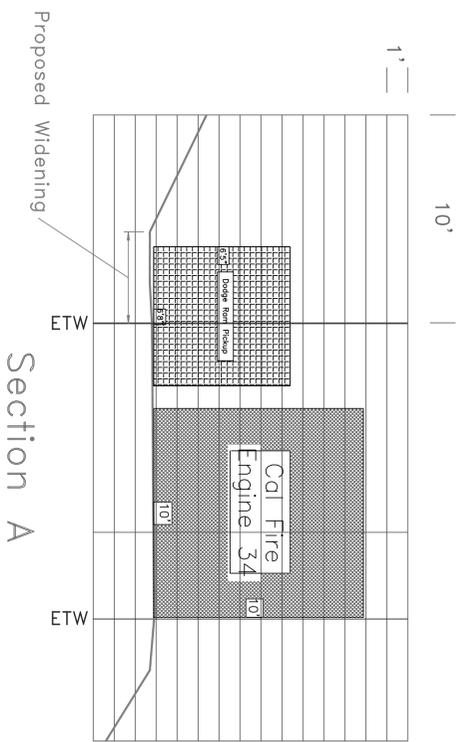
Section A

Old Kiler Canyon Road
Existing Cross Sections
Kiler Ridge Olive Farm
11111 Kiler Canyon Rd
